TTC EVALUATION REPORT

Report No. TTC-2007.01

**Review of Test Data
and Field Trials
for the MainSaver
Process**

April 9, 2007

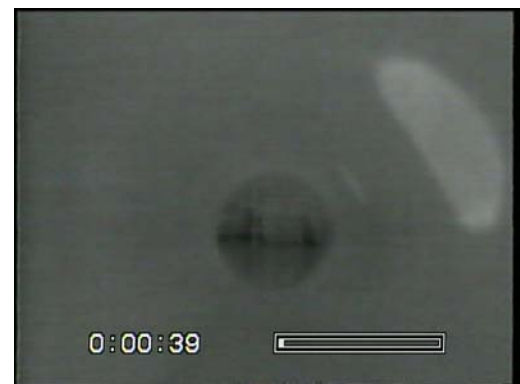
Two 10-ft sections of 8 inch diameter PVC pipe were specially prepared with various cutouts in the wall of the pipe. The pipe sections were lined with the cutouts in place but then the cutouts were removed and the grout carefully removed within the cutout areas. Prior to scanning, the cutouts were replaced over the sections with missing grout. In the infrared scan done with the pipe on the floor of the shop building, the missing areas of grout are clearly visible as localized white areas within a grey overall color representing the surface temperature of the remainder of the lining surface (see top adjacent figure). The two sections of lined pipe were then buried at about 4-5 ft in depth within an approximately 300-ft long section of 8-inch diameter PVC pipe. The defect areas still showed up clearly within the lined pipe sections (see bottom adjacent figure).

Infrared scan from bench test section

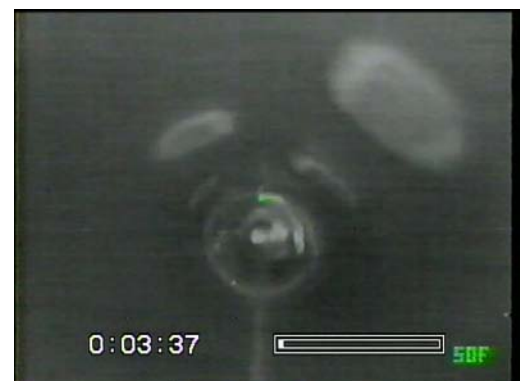
Infrared scan of buried test section

The ability of the infrared scan to pick up missing grout sections provides an important quality assurance for the main area of concern for field installation of the liner – that the liner will be installed with an apparently

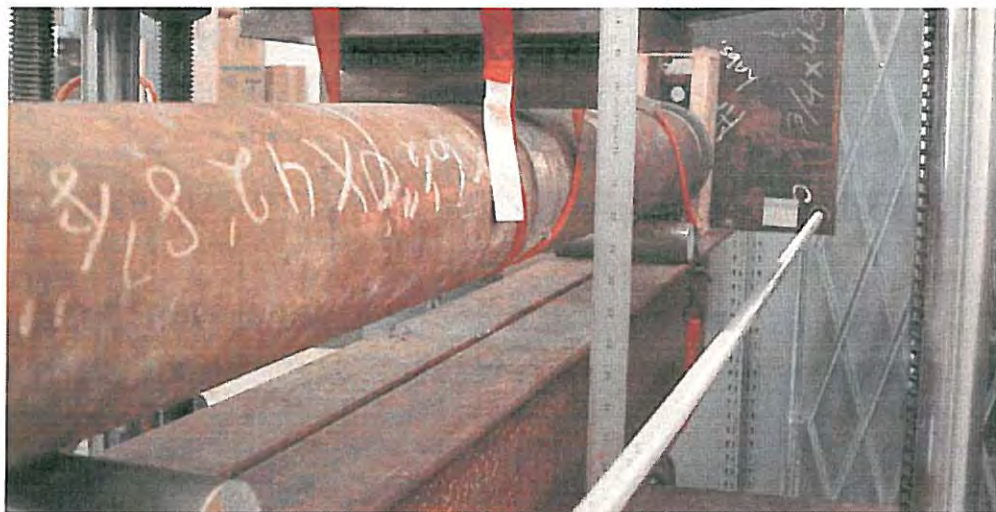
Figure 1: Sample PII-DJIP-4 in the UTM fixtured for three-point bend testing of the butt joint (just left of the vertical scale).

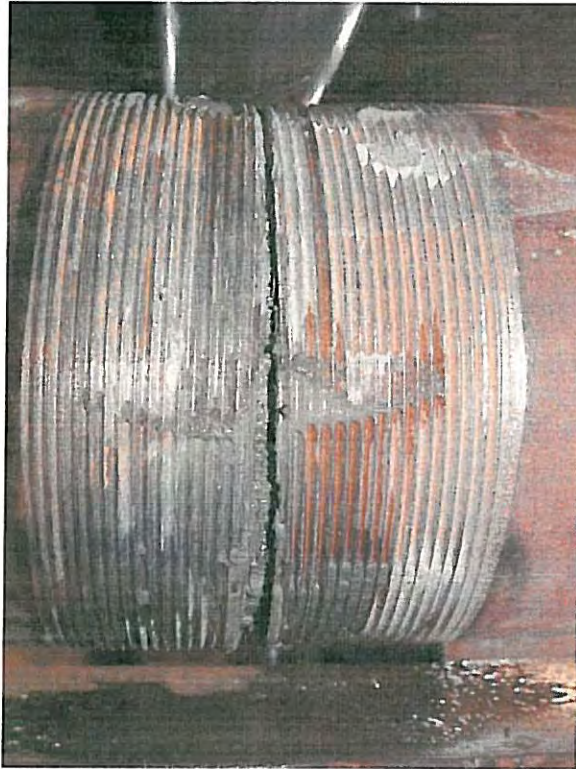
RESULTS: Sample PII-DJIP-4 was pressurized to 45 psi internal hydrostatic pressure and withstood a maximum mid-span deflection of 0.49 inches. The 0.49 inch mid-span deflection corresponds to an angular deflection at the butt joint of 2.30 degrees. The sample did not fail by catastrophic rupture, but displayed leakage from the butt joint area after reaching 0.49 inches deflection (See Figure 2).

Figure 2: Sample PII-DJIP-4 at 0.49 inches deflection (with leakage).

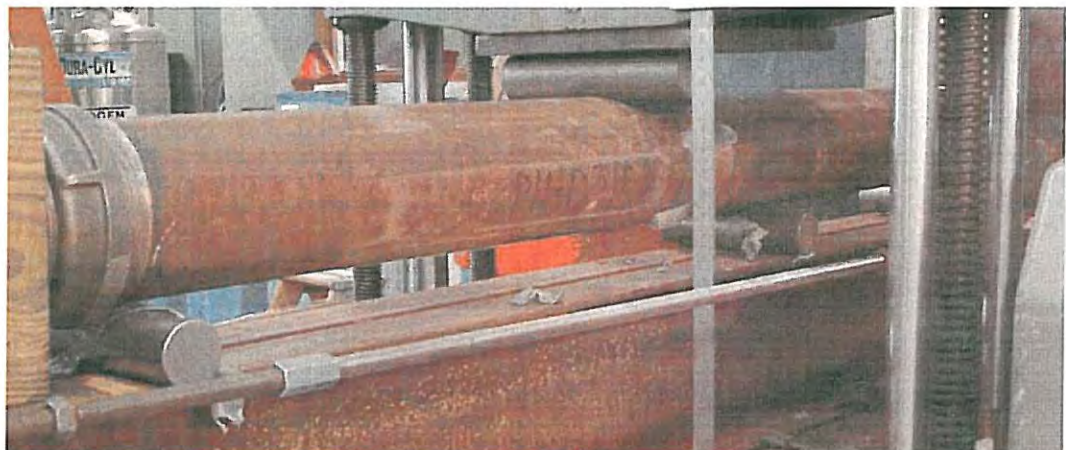
Figure 1: Sample PII-DJIP-3 in the UTM fixtured for shear deflection testing of the butt joint (behind vertical scale).

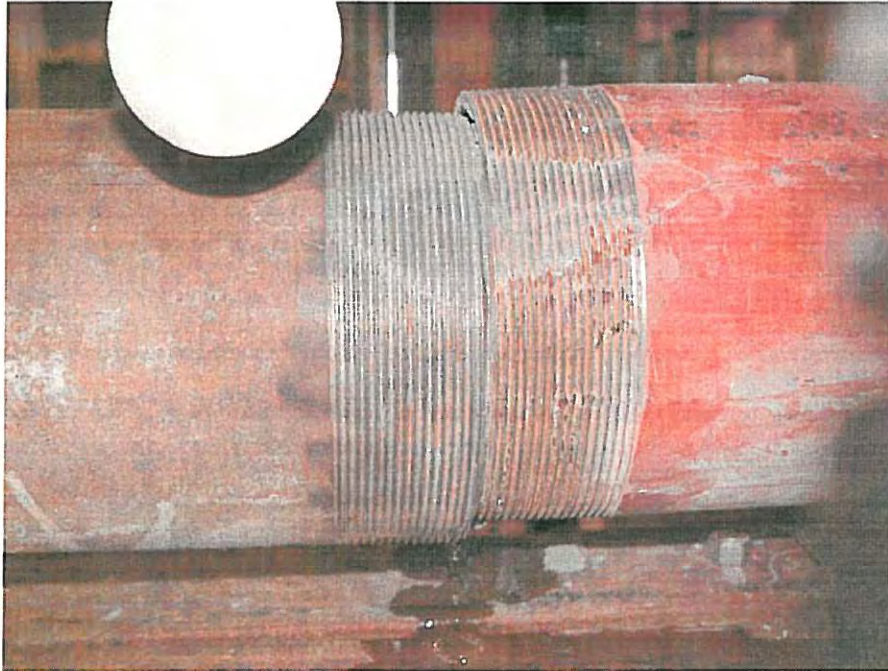
RESULTS: Sample PII-DJIP-3 was pressurized to 45 psi internal hydrostatic pressure and withstood a maximum shear deflection of 0.50 inches. The sample did not fail by catastrophic rupture, but displayed leakage from the butt joint area after reaching 0.50 inches deflection (See Figure 2).

Figure 2: Sample PII-DJIP-3 at 0.50 inches deflection (with leakage).
