TTC EVALUATION REPORT

Report No. TTC-2007.01

**Review of Test Data
and Field Trials
for the MainSaver
Process**

April 9, 2007

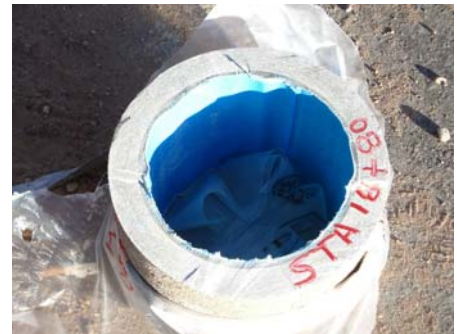
Field Sample from City of Albuquerque Project

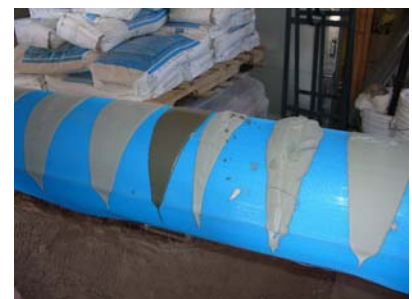
At this time, the grout material selection had been completed and a proprietary grout from a major grout supplier had been selected. Observation of the flow, consistency and separation properties of grout were visually observed by allowing the various grout mixes to flow over the studded side of the liner draped over a pipe (see photo). All the grout mixtures showed good consistency and no tendency to separate. The

Visual Comparison of
Grout Properties

criteria for selecting the best mix proportions were good flow properties with minimal cracking of the grout during drying (note the grout is fully exposed on one side during drying in this test but is not exposed in the real application).

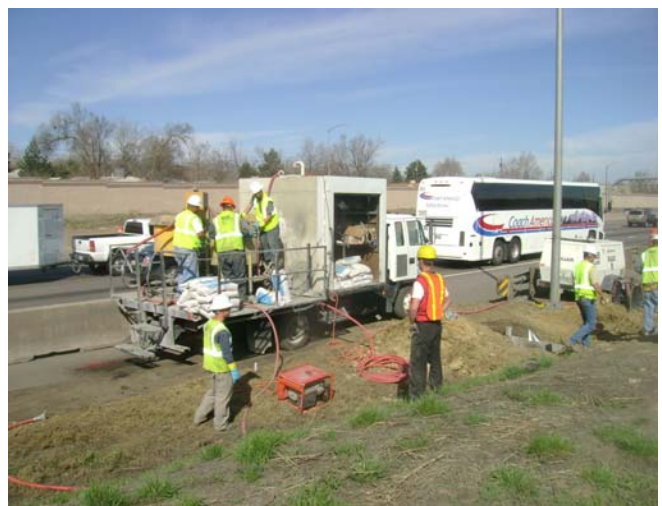
During some prior construction work related to I-25, an asbestos cement water line was damaged beneath the freeway and was considered to be a significant risk for a future failure. To replace the water line, a

MainSaver Installation under I-25 in the City of Thornton

directional bore had been planned for the approximately 300 ft long crossing. Mr. Gay had become aware of the MainSaver process and had attended both a demonstration in Fairplay and one of the field installations in Albuquerque in late summer 2006. He was able to get approval to try the technique on what was expected to be a straight segment of pipe. In fact, the longitudinal profile of the pipe across the freeway resembled a flattened “W” shape. The MainSaver lining was pulled in, grouted and cured without incident and the line was pressure tested to 200 psi. It also quickly passed the bacterial test.
